### Vehicle Inspection Report

**Reg:** LRZ8519

**VIN:** VF77DBHY6GJ867956

<b>Make</b>	Citroen	<b>Transmission</b>	Manual
<b>Model</b>	Berlingo 1.6 BlueHDi 850kg Enterprise	<b>Gears</b>	5
<b>Body Type</b>	Van	<b>Date First Reg</b>	10/02/2017
<b>Mileage</b>	35,774 miles	<b>Doors</b>	3
<b>Fuel Type</b>	Diesel	<b>Colour</b>	White
		<b>Year of MFR</b>	2017

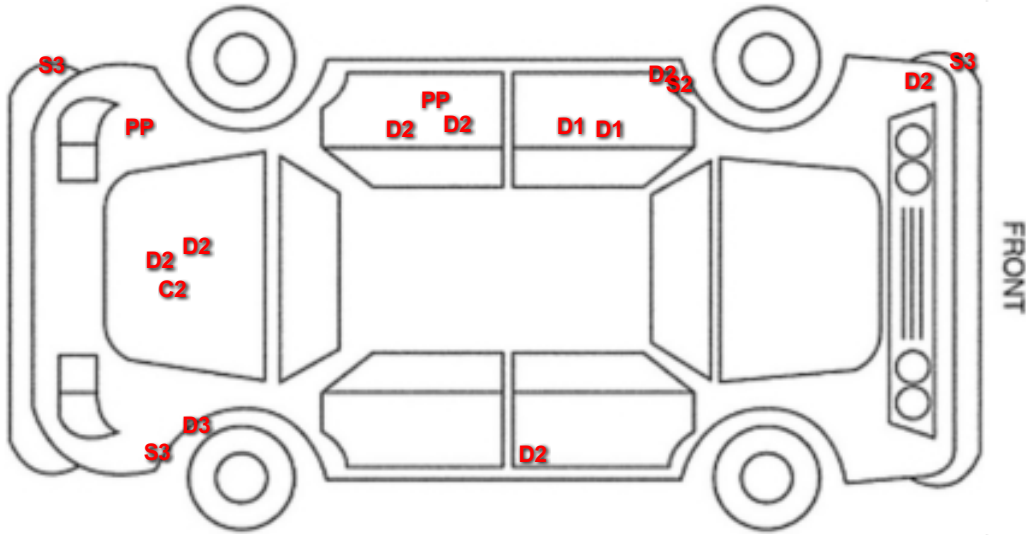
Vehicle Splat

**Bumper Front**

Scratched  
Over 100mm  
Thru Paint  
Refinish

**Wing nsf**

Dented  
Over 30mm  
Repair and  
Refinish

**Door nsr**

Dented  
With Paint  
Damage  
Repair and  
Refinish

**Qtr Panel nsr**

Poor Previous  
Repair  
Poor Paint  
Refinish

**Qtr Panel osr**
