Vehicle Inspection Report

Reg: GF16MSV

VIN: WV1ZZZ7HZGH105344

| Model | Transporter T28 Swb 2.0TDI BMT 102 | Gears | 5 |

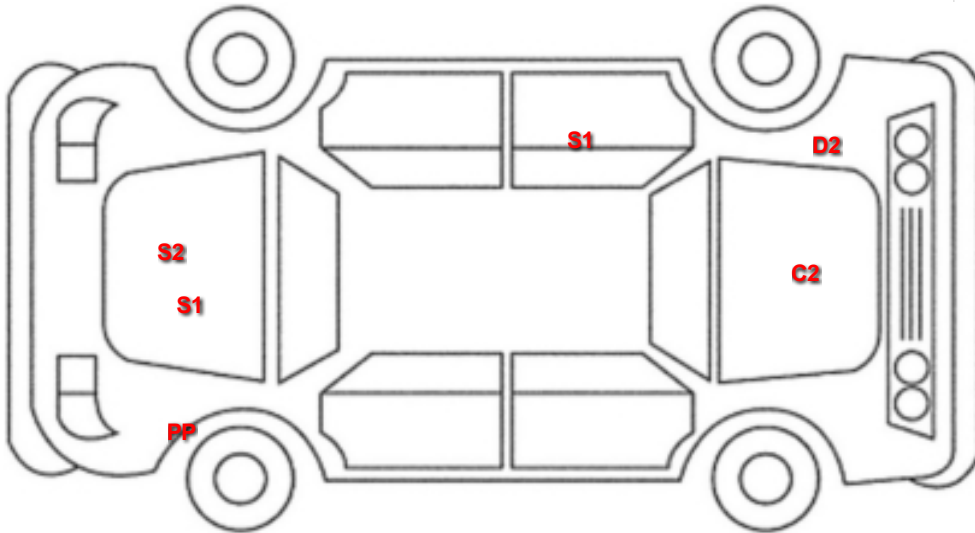
Vehicle Splat

Seat Base Cover osf

Burn
UpTo 3mm
Smart Repair

Bonnet

Chipped
1 To 5
Smart Repair

Wing nsf

Dented
Over 30mm
Repair and Refinish

Bumper Front

Insecure
Action Required
Smart Repair

Door nsf

Scratched
UpTo 25mm Thru Paint
Smart Repair

Tailgate

Dented
With Paint Damage
Repair and Refinish

Qtr Panel osr

Poor Previous Repair
Poor Paint
Refinish
