### Vehicle Inspection Report

**Reg:** LRZ8519

**VIN:** VF77DBHY6GJ867956

<b>Make</b>	Citroen	<b>Transmission</b>	Manual
<b>Model</b>	Berlingo 1.6 BlueHDi 850kg Enterprise	<b>Gears</b>	5
<b>Body Type</b>	Van	<b>Date First Reg</b>	10/02/2017
<b>Mileage</b>	35,774 miles	<b>Doors</b>	3
<b>Fuel Type</b>	Diesel	<b>Colour</b>	White
		<b>Year of MFR</b>	2017

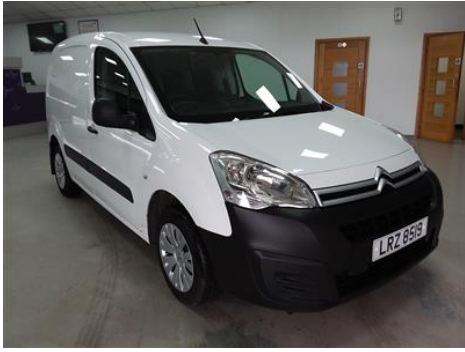
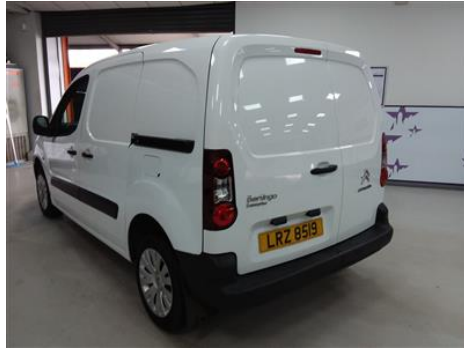
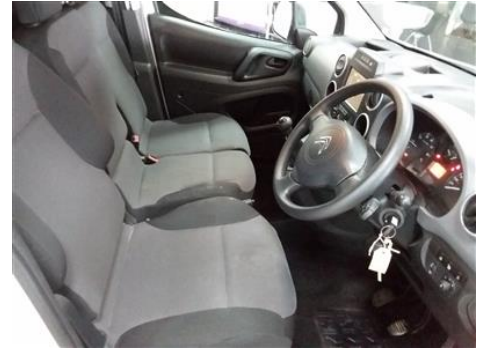
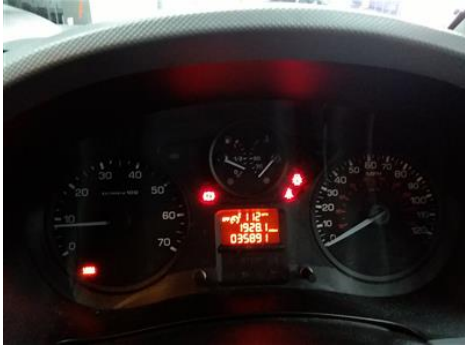
**Bumper Front**

Scratched  
Over 100mm  
Thru Paint  
Refinish

Dented  
Over 30mm  
Repair and  
Refinish

Dented  
With Paint  
Damage  
Repair and  
Refinish

Poor Previous  
Repair  
Poor Paint  
Refinish
